The trouble with fireplace inserts

How this popular stove can drive a chimney sweep to tears, and why you should get the thing out of the house if you're not willing to have it properly installed, operated and serviced.

By Gary Olsen & Jay Hensley

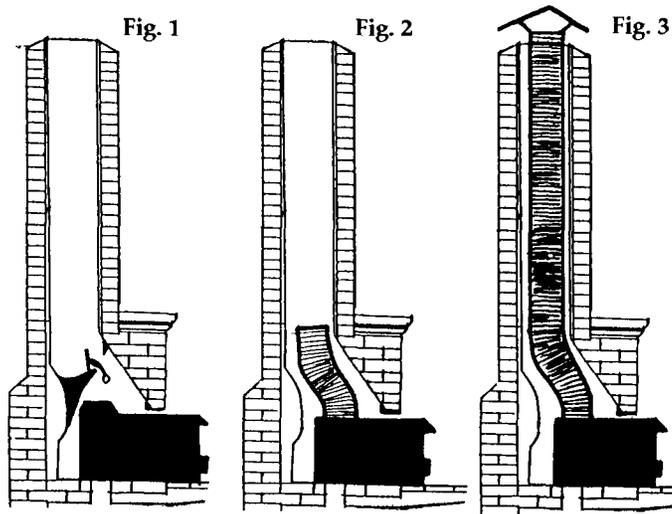
Three ways you will find fireplace inserts installed. Only Figure 3 meets the full approval of most stove installers and chimney service professionals.

Fig. 1: This shows an improperly-installed fireplace insert. This type of "just-shove-it-into-the-fireplace" installation causes excessive amounts of creosote to be deposited on the walls of the firebox, smoke chamber and flue. The chimney was built for fireplace use and is too big for the combustion-air-controlled appliance it now serves.

Fig. 2: This shows the insert's pipe connected to the first tile of the flueliner. It is the MINIMUM installation required by the National Fire Protection Association's (NFPA) 211 standard. In reality, it does not work well in most cases. It's like using a band-aid when surgery is needed.

Fig. 3: This shows a full liner running from the stove to the top of the chimney. There are many types of tested and listed liners to take flue gases quickly and safely out of the house without allowing creosote time to cool, condense out onto flue walls and cause trouble.

Many smoke chambers and chimneys ARE TOO BIG to properly vent an insert stove. A typical masonry chimney, designed to vent an open fireplace, has a 12 by 12-inch tile liner (144 square inches). The average insert stove requires an 8-inch round chimney, or about 51 square inches. This helps speed the much smaller volume of flue gases up and out of the chimney before they have a chance to cool down and cause trouble.

The villain here, the thing that creates a safety hazard, is the excessive production of creosote. Creosote is contained in the volatile flue gases coming up the chimney with the smoke. When these gases are allowed to linger in the flue because of an oversized chimney, they cool, causing the creosote to condense onto the walls of firebox, smoke chamber and chimney.
